San Clemente Habitat Restoration & Stormwater Management Project: Annual Monitoring Report

**Cheadle Center for Biodiversity & Ecological
Restoration**

12/31/2011

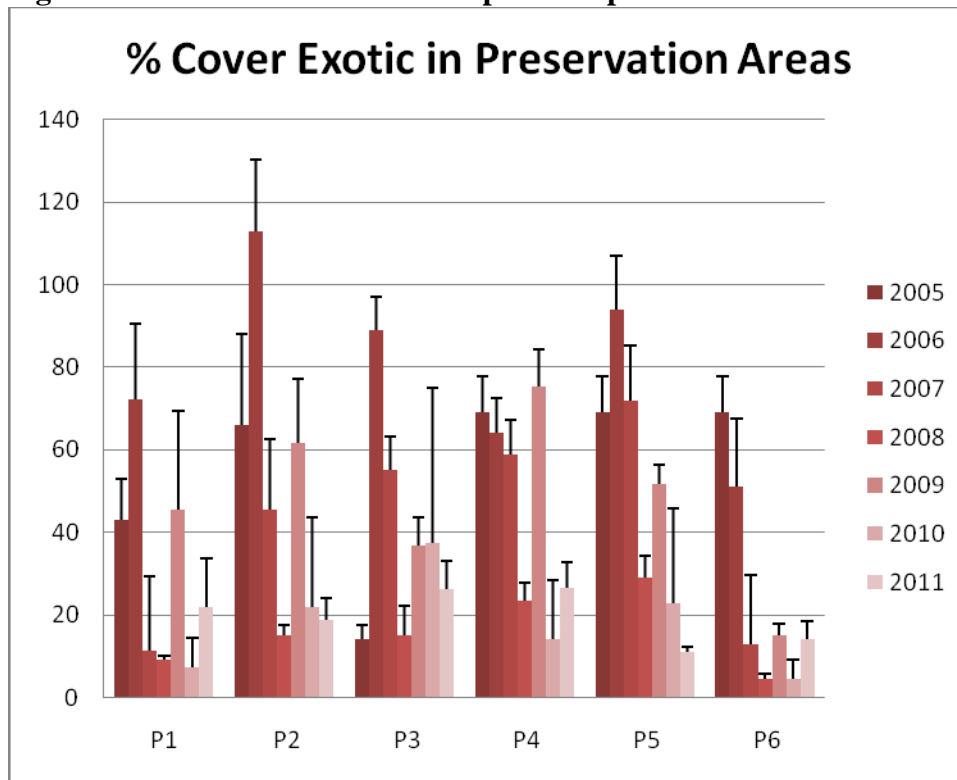
Figure 4. Percent cover for exotic species in preservation areas from 2005-2011

In 2011, exotic cover remained relatively the same with some areas increasing around 10% and others dropping about the 10%. Looking at past results it may come as no surprise that area P3 once again failed to pass performance standards, but at least saw an over 10% decline in exotic cover from 2010.

In 2010, all areas showed a decline in exotic cover compared to a less than successful year in 2009, most dropping quite significantly with the exception of P3, which increased slightly and managed to fail performance standards for the 5th consecutive year.

All exotic species percent cover values more than doubled in 2009 relative to 2008 bringing three of the tarplant preservation areas into the red. (P1, P3, P4) from that of baseline conditions, and therefore are deemed unsuccessful. Up until 2009 a decline could be seen in exotic percent cover for each year in the monitoring period to date except for the first year after baseline monitoring. The tarplant areas contain poor growing conditions with weed infested seed banks of small stature weeds such as Bermuda grass, and bur clover. Due to tarplant's late phenology, it is usually present but is very tiny and susceptible to being killed by disturbance

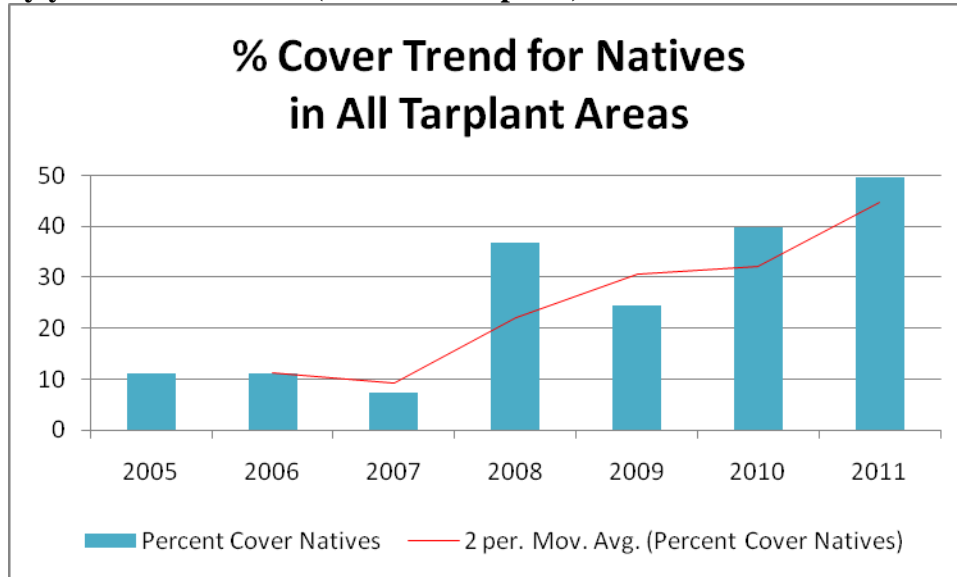
Figure 10. Trend for the percent cover of native species in all preservation & creation areas by year for 2005-2011 (*includes tarplant)

As in most of the individual transect areas the tarplant population as a whole for the San Clemente site declined following the baseline year, but drastically increased in 2008 due to an enhanced management and propagation plan. Yet in 2009 a decrease of 10 percentage points was seen. In 2010 a marked increase in the population was seen and then repeated in 2011. Both a careful management approach and optimum environmental conditions lead to these banner years for the sites tarplant population. It is also important to note that this pioneering disturbance following species is prevalent in many other areas of the site that are not monitored, especially areas close to our numerous constructed wetlands. Because of this one must be careful in judging the health of the entire San Clemente population on these figures alone. Please refer back to section 3.1 for another form of monitoring, which displays a more comprehensive perspective of the entire sites population.

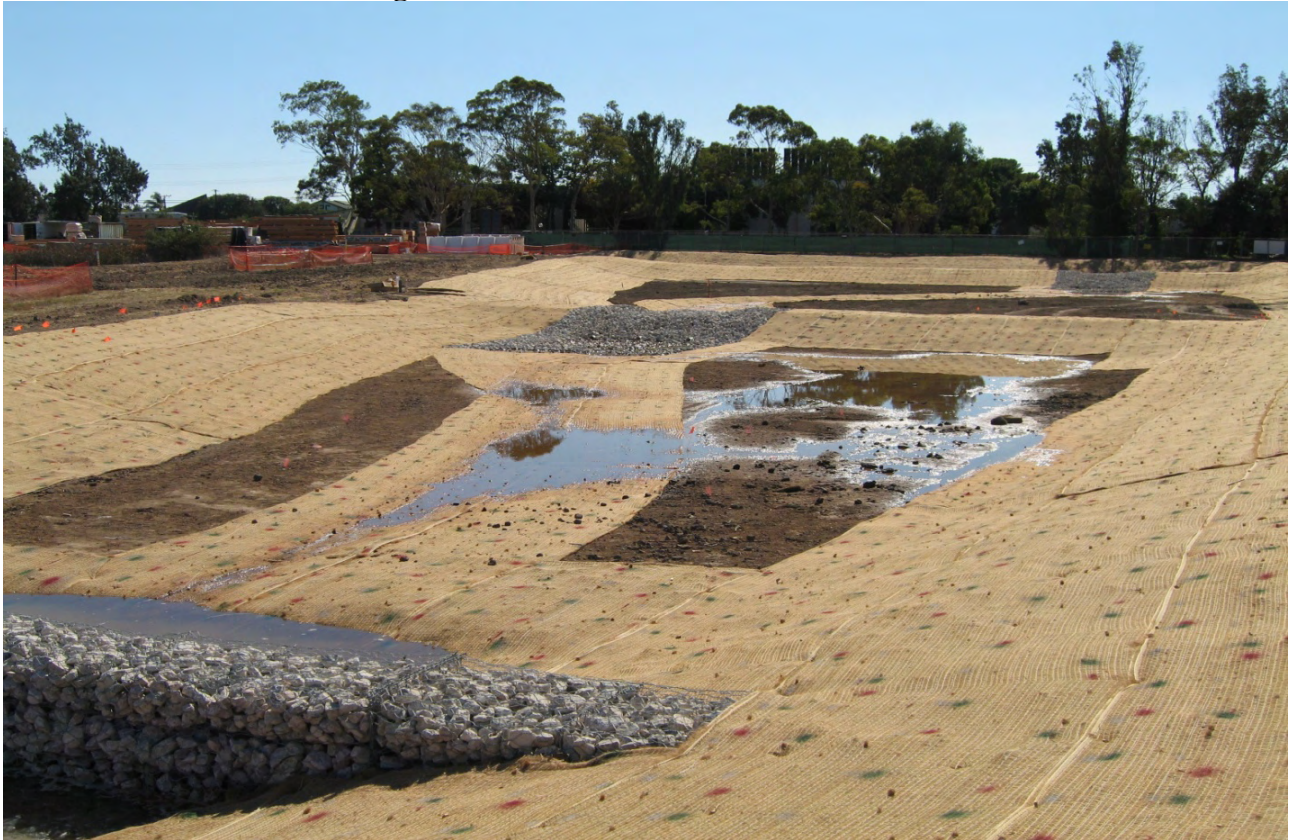
Photo 9. SMS coconut netting for erosion control

In 2009, erosion control was carried out in the new field drainage swale and the new parking lot swale. All exposed slopes were covered in 3,000 square feet of coconut netting. After applying the netting, the restoration staff laid down approximately 2,900 square feet of mulch over the netting to further reduce erosion and help establish conditions conducive to native vegetation. Three large check dams were added in the upper portion of the redesigned field drainage on the slope leading into the swale from the recreational field and two check dams were added to the parking lot swale. Since these efforts took place, we have received two large storm events and the system's held up very well. CCBER restoration staff continues to conduct detailed inspections of all wetland BMPs to ensure their proper performance and integrity before, during, and after storm events.

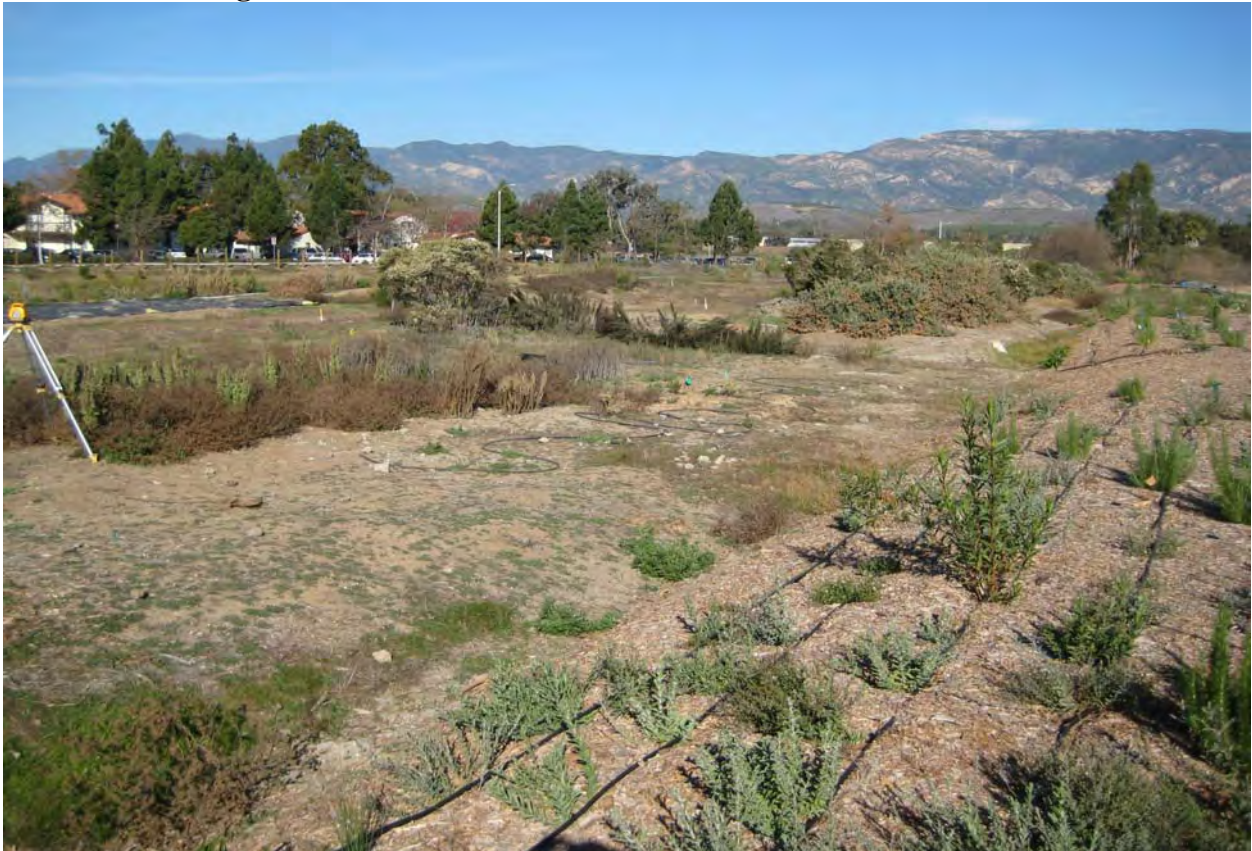
Photo 26. Existing wetland south before enhancement

The existing wetland can be divided into two distinct sections. The first is of high quality composed of a native vernal pool and marsh located at the head of the wetland network. This portion can be seen on aerial imagery from 1928 and is a remnant of a much more extensive wetland system. This more extensive wetland was bisected shortly after 1928 by the building of Los Carneros road directly on its current western edge. This caused water, which would normally flow into a larger expanse of wetlands to the west, to take an immediate right turn to the north along the east side of the new road. This, in essence, created the second, linear portion of the wetland we have today. This new portion of wetland sustained a hydrology sufficient to support mostly non-native facultative-wet wetland species with a few scattered native obligates. The main reason for this was not a lack of water to the wetland area, but a lack of retention time in a basin that was really no more than a road side ditch. Fortunately, the topography surrounding the wetland allowed for relatively easy improvement. These improvements increased retention time and area of inundation of the wetland sections, and they allowed for the expansion of the site's vernal pool habitat. This new vernal pool network's central location within the site provides a dramatic contribution to the entire site's ecological functionality, as evidenced by the use of it by multiple trophic levels. In all, a length of 262 ft of marginal wetland was converted to a network of vernal pools comprising 3,111 sf. (Photos 26-36, pgs. 95-100).

The three enhanced portions of the existing wetland totaling 3,111 sqft were planted with a plant suite characteristic of vernal pools. This palette included Common Spike Rush (*Eleocharis macrostachya*), Parish's Spike Rush (*Eleocharis parishii*), Field Sedge (*Carex praegracilis*), Yerba Mansa (*Anemopsis californica*), and Meadow Barley (*Hordeum brachyantherum ssp. brachyantherum*). 211 cups of vernal pool inoculum was also applied to the newly enhanced vernal pool areas as well. The inoculum material was collected from four different vernal pools in the immediate area, three of which were restored and one naturally occurring. Inoculum was collected once the pools had completely dried out and all plants had gone to seed. Inoculum was taken by scraping one foot square patches of soil and plant material with a garden hoe. Inoculum was harvested from both the inner and outer rings of the pools and labeled as such because very different suites of plant materials and organisms may be found in each. The inoculum was spread evenly throughout the pools in the respective rings according to surveyed elevations and coconut net was applied over the top to help bind the seed and provide erosion control. Coyote Thistle (*Eryngium vaseyi*), and Dwarf Woolly-Heads (*Psilocarphus brevissimus*) have already germinated in the pools.
